FIELD OVERSIGHT SUMMARY REPORT
ACS NPL SITE
GRIFFITH, INDIANA
February 6, 1997 - March 28, 1997

**USEPA/ARCS V
BVSPC Field Oversight Summary**

Reporting Period: February 6, 1997 - March 28, 1997

Site Name/Location: ACS, Griffith, IN

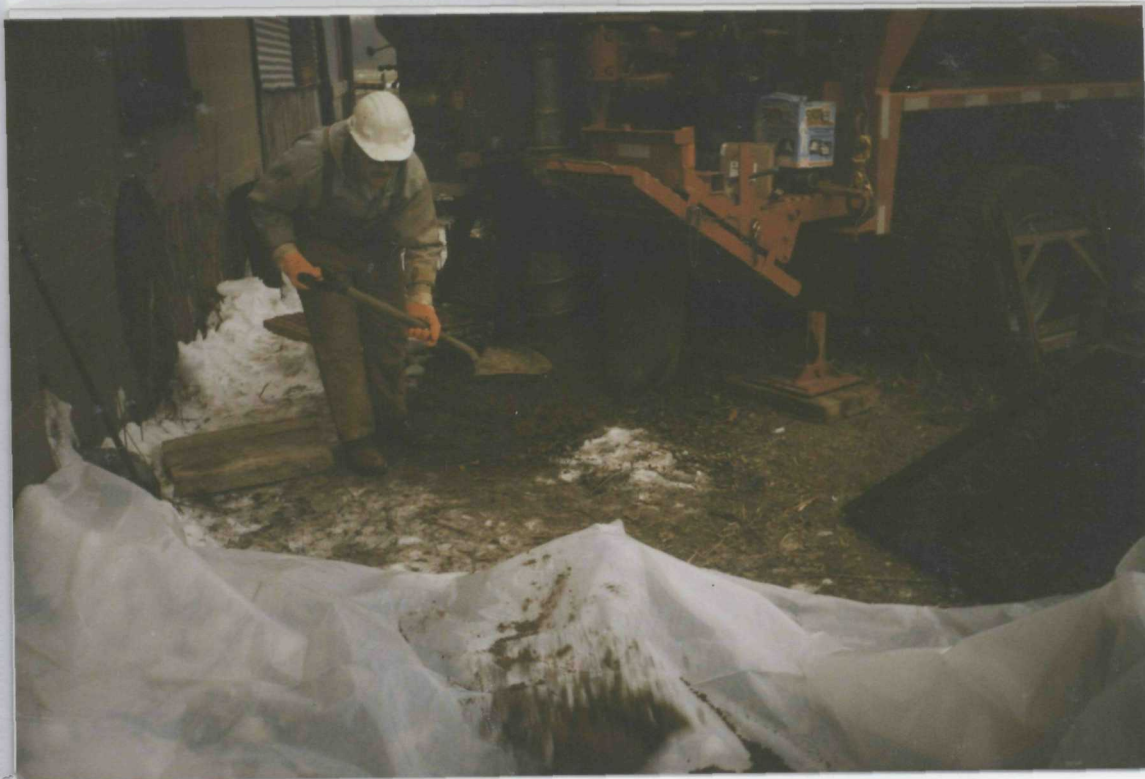
The 4-inch diameter PVC well casing was overdrilled using 8 1/4-inch inside diameter (ID) hollow-stemmed augers to the top of the upper clay layer, i.e., approximately 30 feet bgs. A 6-inch stainless steel casing was then installed to a depth of 35 feet bgs and grouted in place to seal off the upper aquifer from the lower aquifer. Before overdrilling, only top 10 feet of the well casing could be pulled out. The rest of the casing was ground up and flushed out during mud rotary drilling.

Site: American Chemical Services, Inc. RD/ERA
Proj. #: 71670.600
Roll: 1 Photo #: 113
Date: 02-07-97 Time: 1425
Photographer: Ashok Rupani
Description: Facing west. Stearns abandoning the K-P Well by
overdrilling with an 8 1/4-inch hollow-stemmed augers.

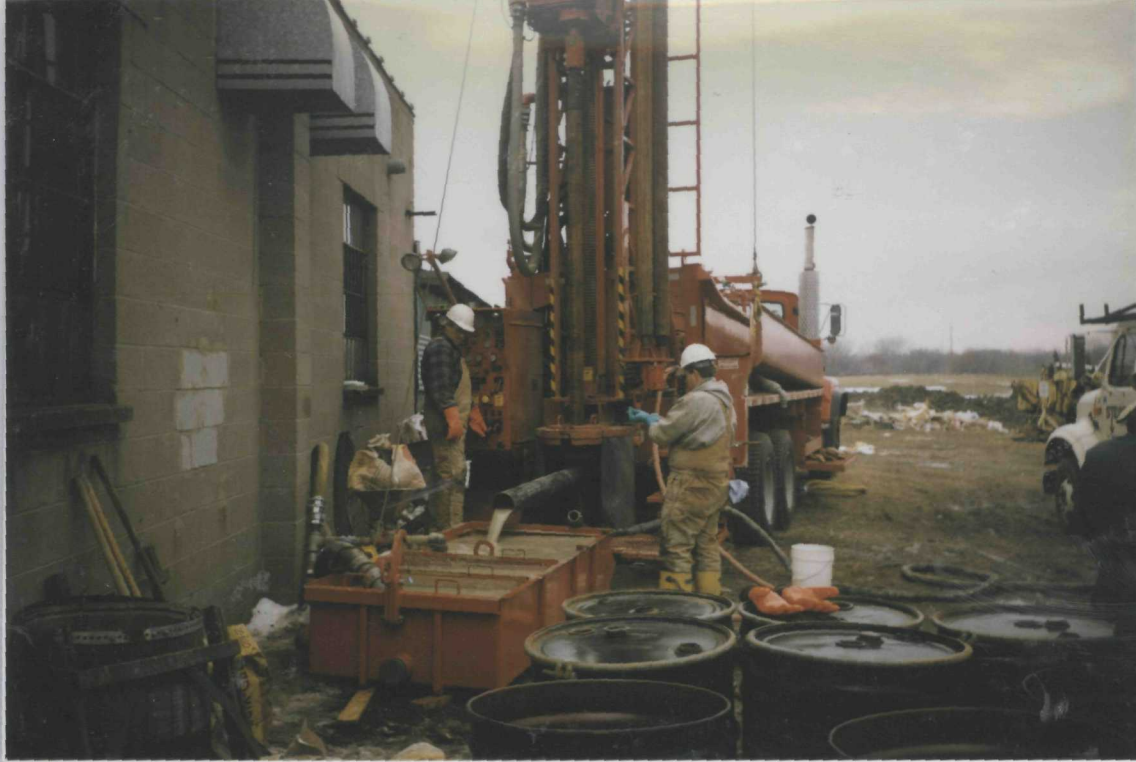
Site: American Chemical Services, Inc. RD/ERA
Proj. #: 71670.600
Roll: 1 Photo #: 114
Date: 02-09-97 Time: 1250
Photographer: Ashok Rupani
Description: Facing west. Stearns using mud rotary method to drill
inside the 6-inch outer casing.

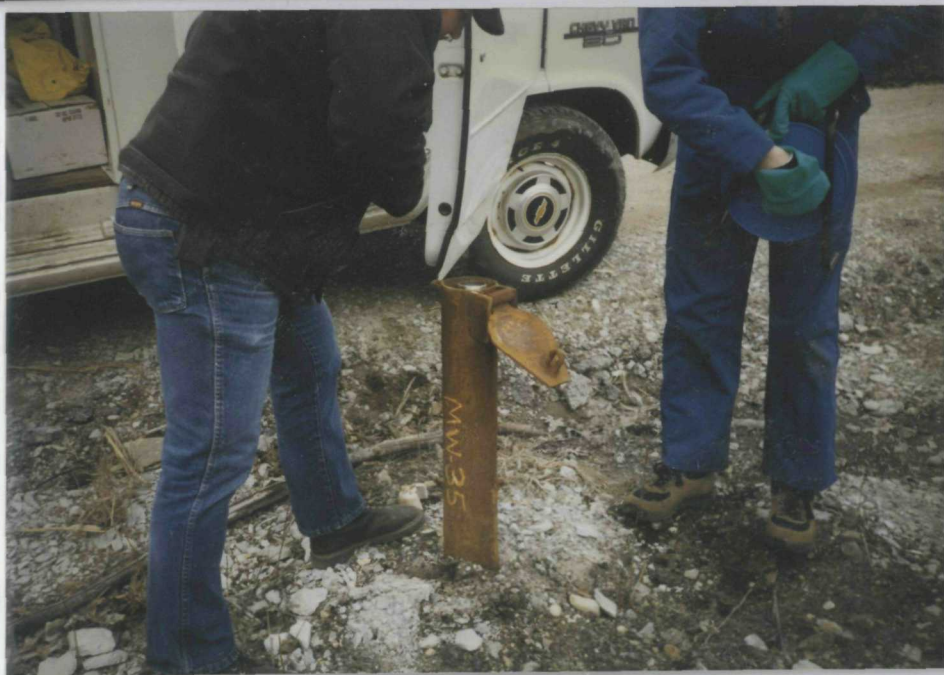
<u>Location</u>	<u>Remarks</u>
Monitoring Well MW-35	Found damaged
Piezometer P-6	Not Found, possibly destroyed
Piezometer P-12	Free Product encountered
Piezometer P-20	Found damaged
Piezometer P-21	Could not locate
Piezometer P-29	Free Product encountered
Piezometer P-30	Free Product encountered
Piezometer P-37	Found damaged

Site: American Chemical Services, Inc. RD/ERA
 Proj. #: 71670.600
 Roll: 4 Photo #: 119
 Date: 03-24-97 Time: 1450
 Photographer: Ashok Rupani
 Description: Facing north-east. Monitoring Well MW-35 was found to be damaged.

- Third Quarterly sampling of lower and upper aquifer wells.
- Residential Well Sampling.
- Sampling of ACS facility well ATMW-4D.
- Sampling of six (6) ACS production wells.
- Installation of a new monitoring wells to replace MW-35 and MW-54.
